Assessment of Dam Safety of Coal Combustion Surface Impoundments

Indianapolis Power & Light Company

Eagle Valley Generating Station

Draft Report

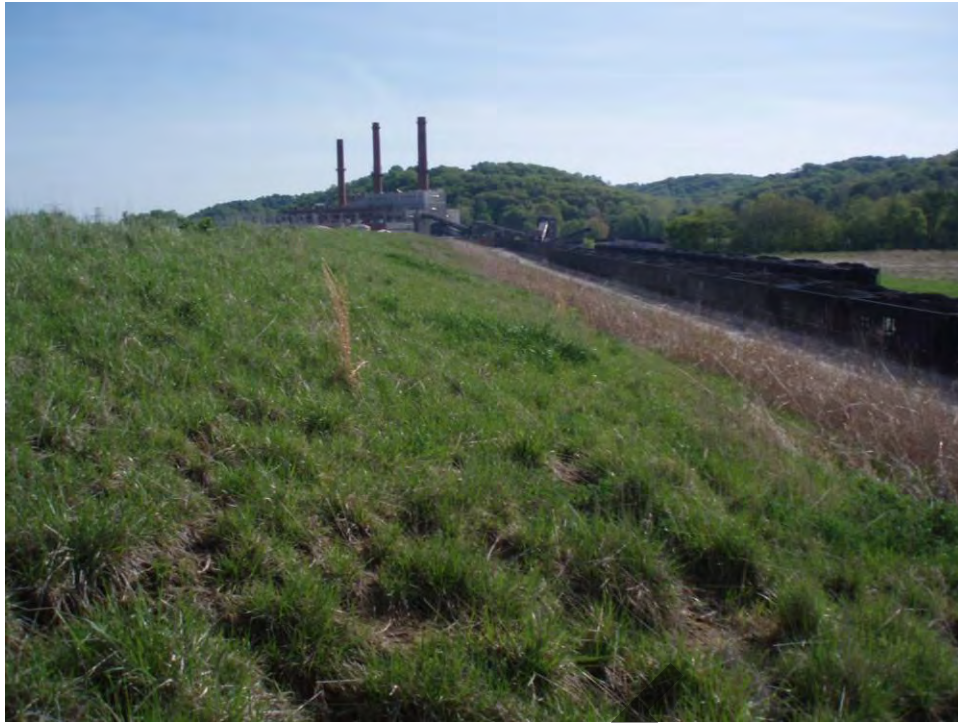
83. Pond D – Southeast embankment exterior slope, looking northeast.

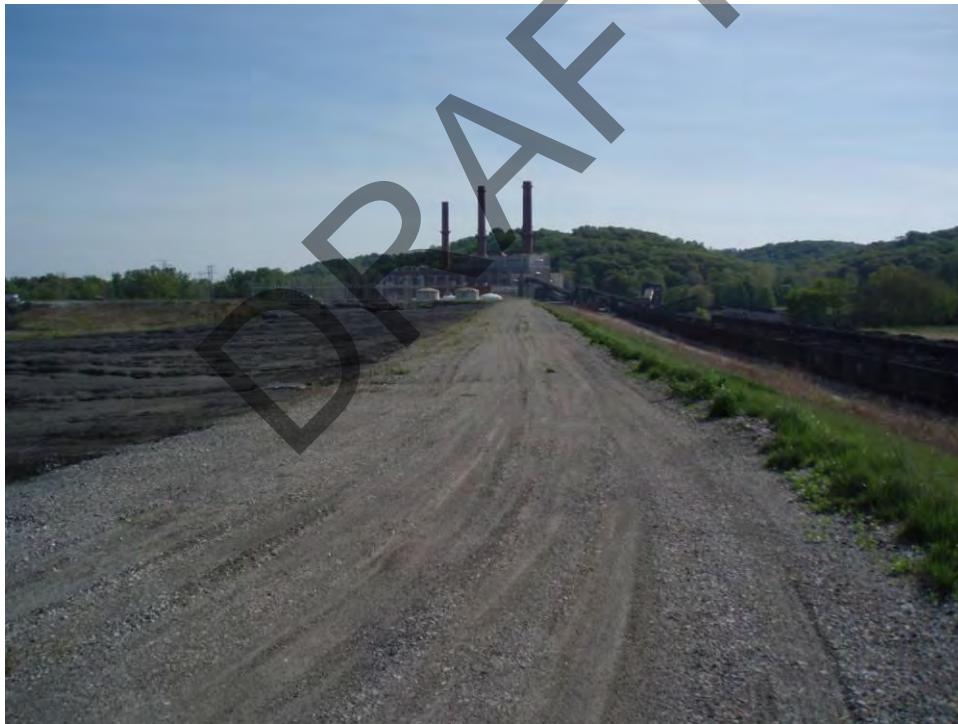
84. Pond D – Southeast embankment crest, looking northeast.

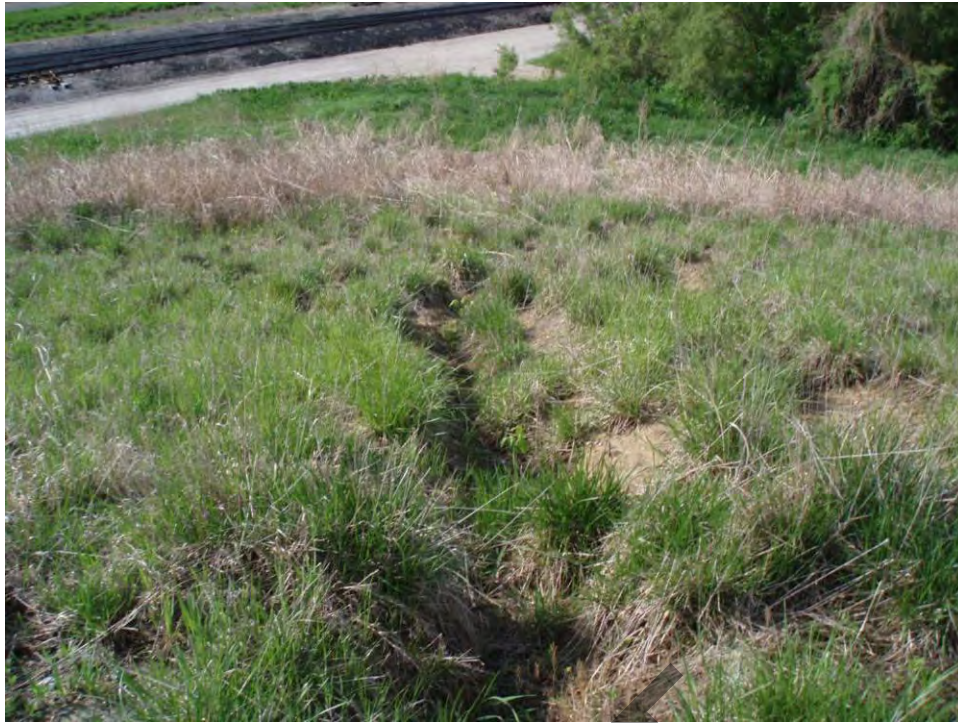
85. Pond D – Erosion rill on southeast embankment exterior slope, looking southeast.

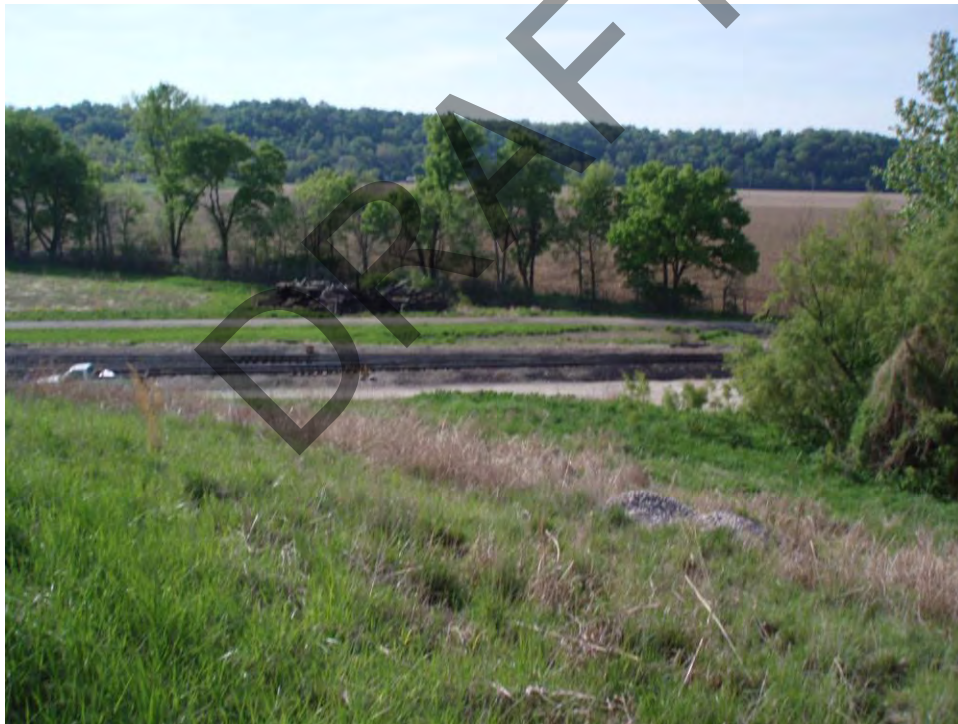
86. Pond D – Southwest corner of southeast embankment exterior slope downstream area, looking southeast.

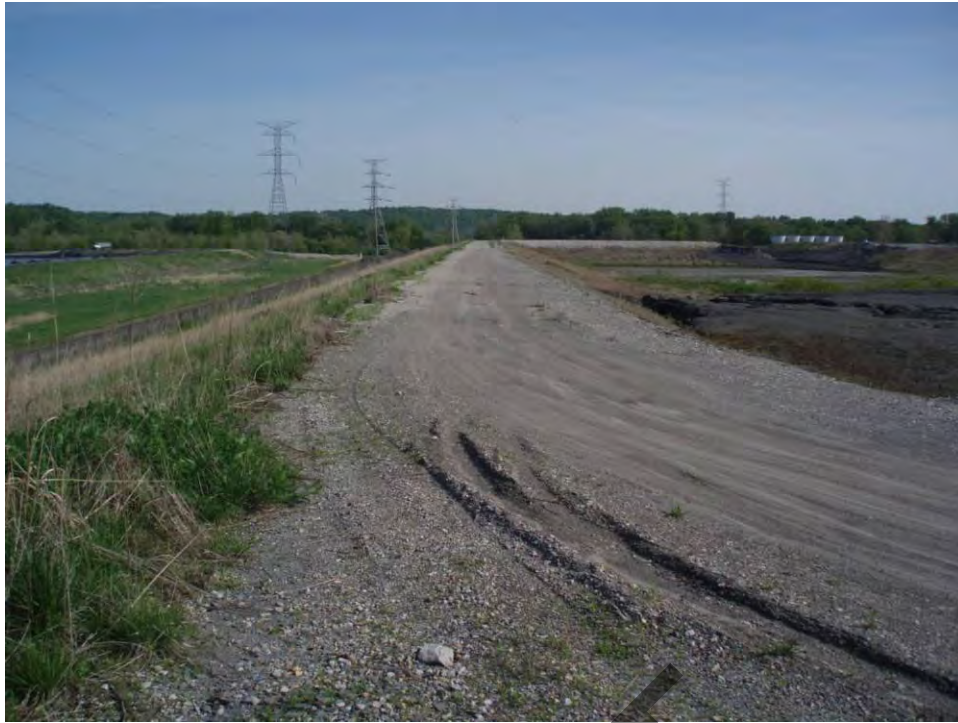
87. Pond D - West embankment crest, looking north

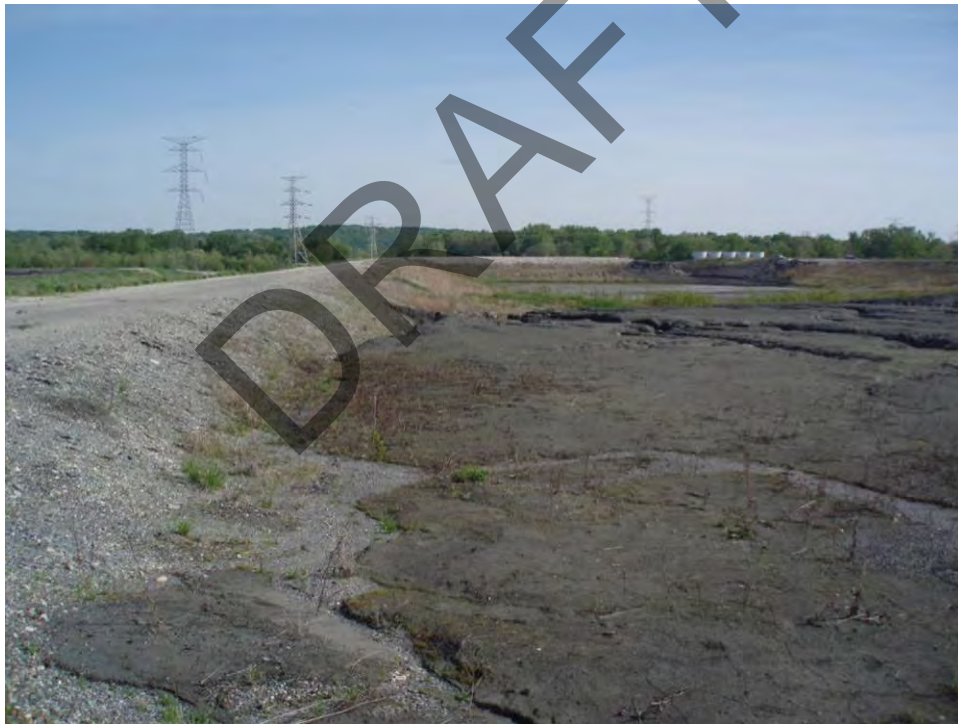
88. Pond D - West embankment interior slope, looking north.

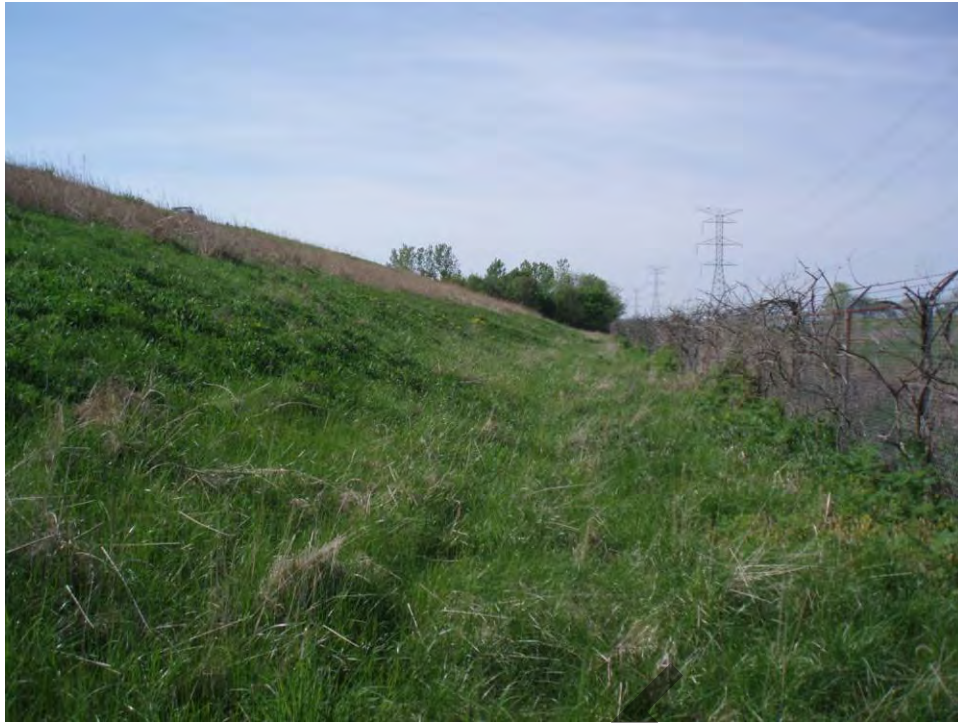
91. Pond D – West embankment exterior slope, looking south.

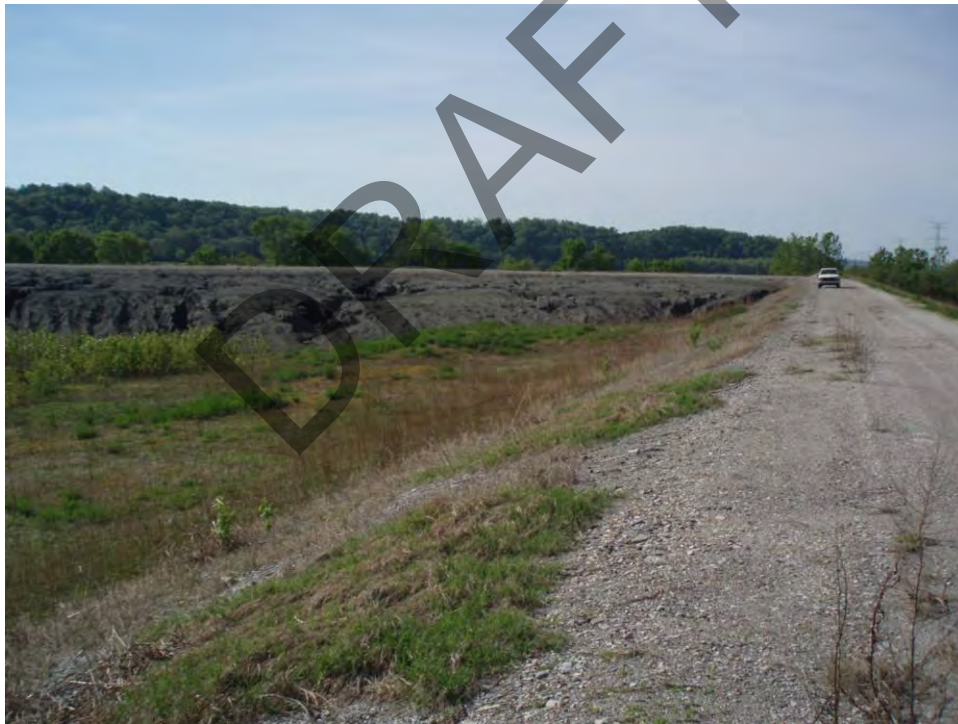
92. Pond D – West embankment interior slope, looking south at edge of ash limit prior to Pond D/E embankment failure.

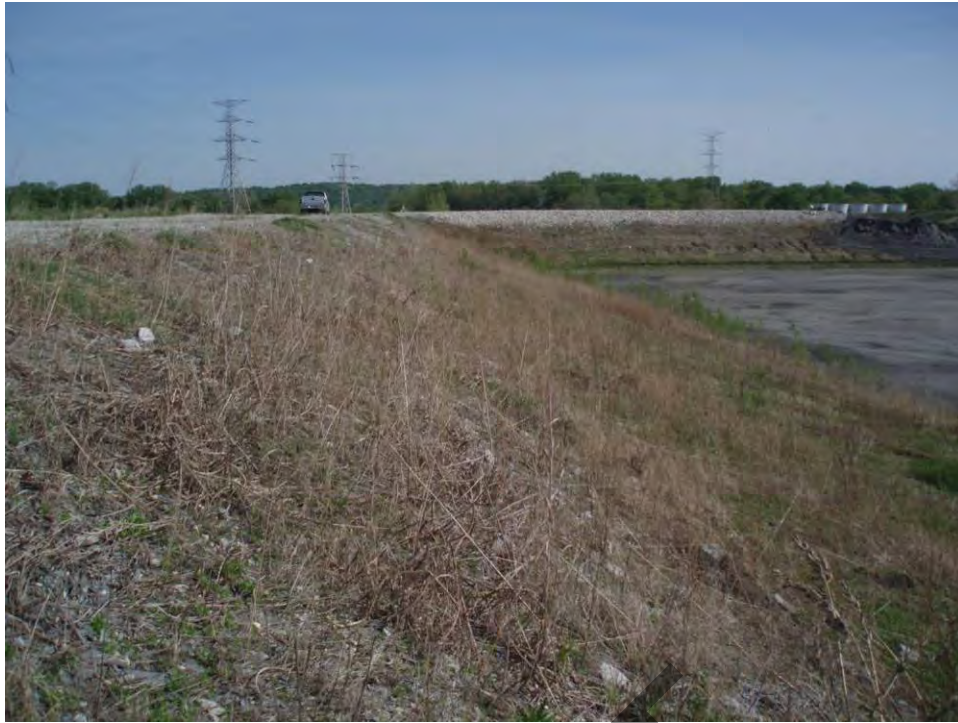
93. Pond D – West embankment interior slope, looking north toward divider embankment D/E.

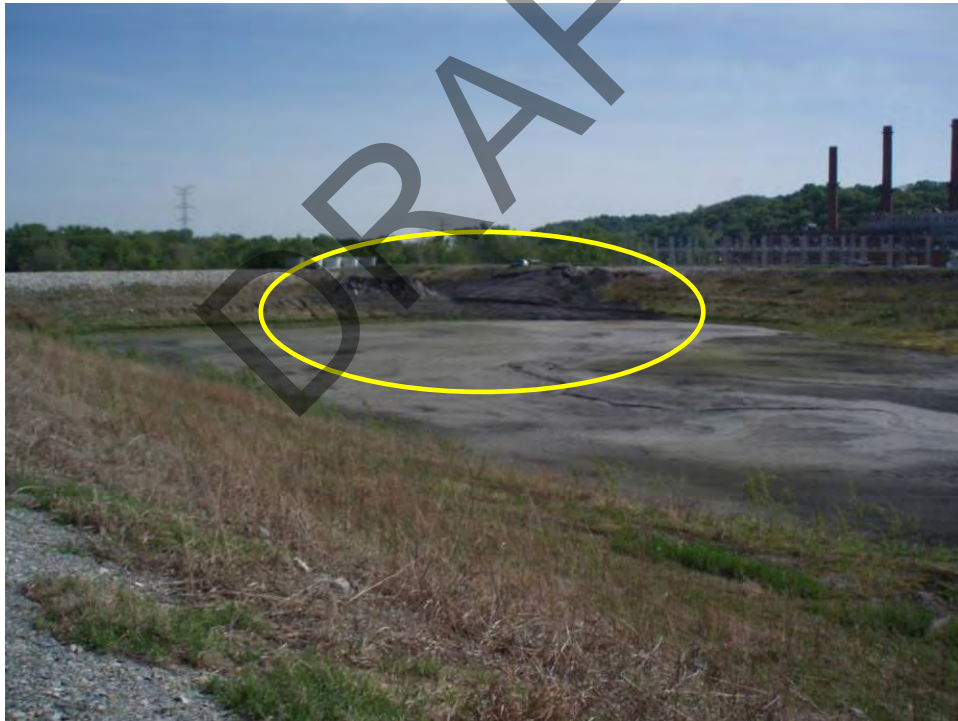
94. Overview of Pond D, south slope of divider embankment D/E, and west slope of Pond D diversion embankment. Note breach (circled) in divider embankment D/E.

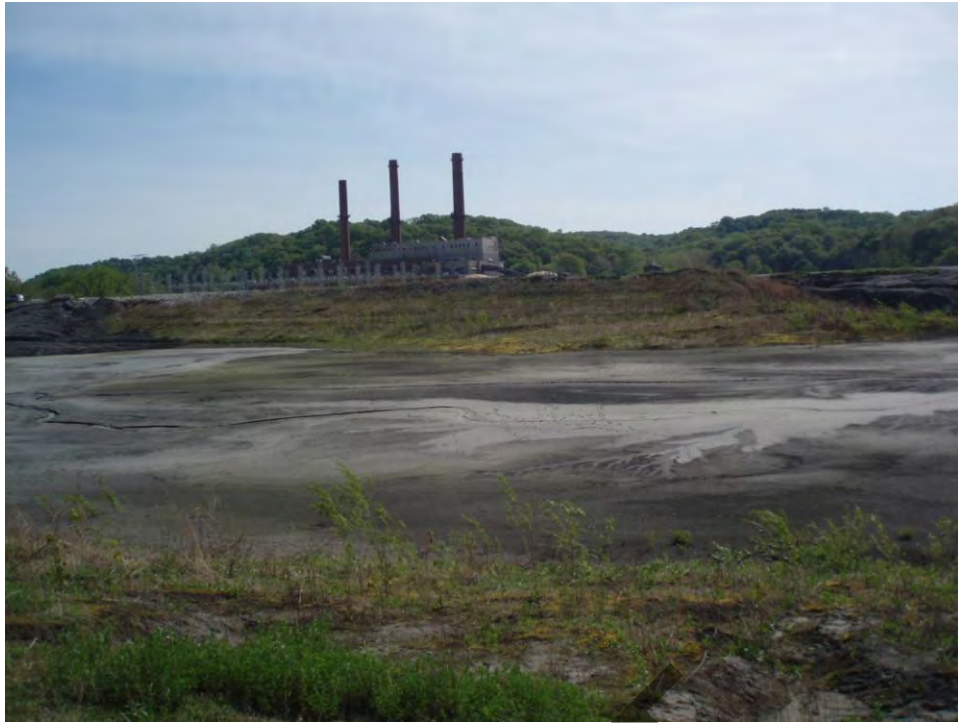
95. Overview of Pond D and west slope of Pond D diversion embankment, looking east.

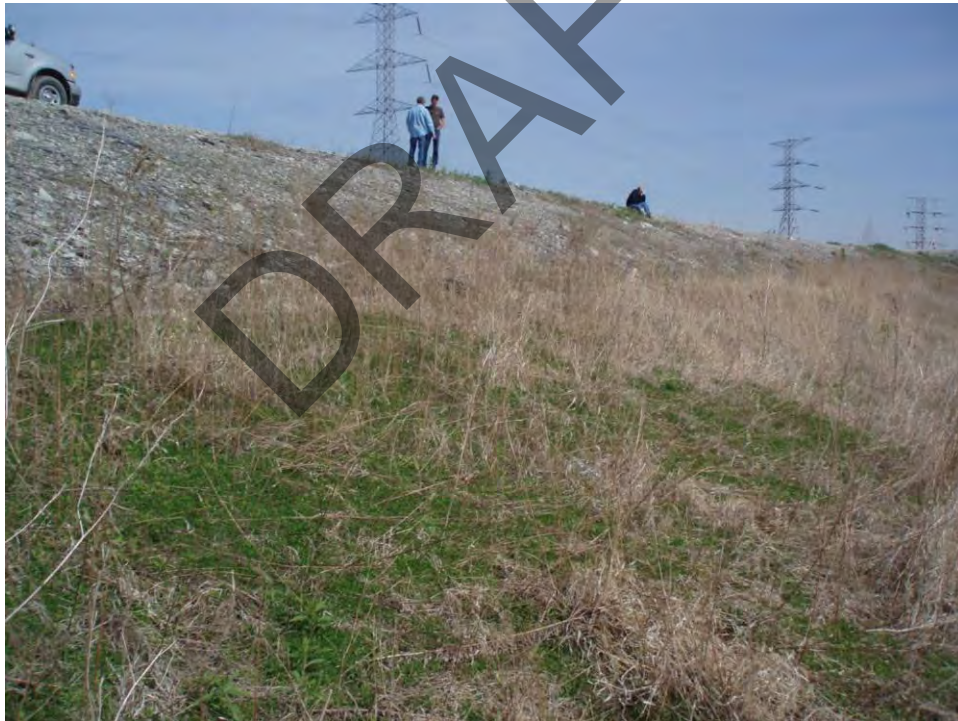
96. Pond D - West embankment typical interior slope with shale armor near crest.

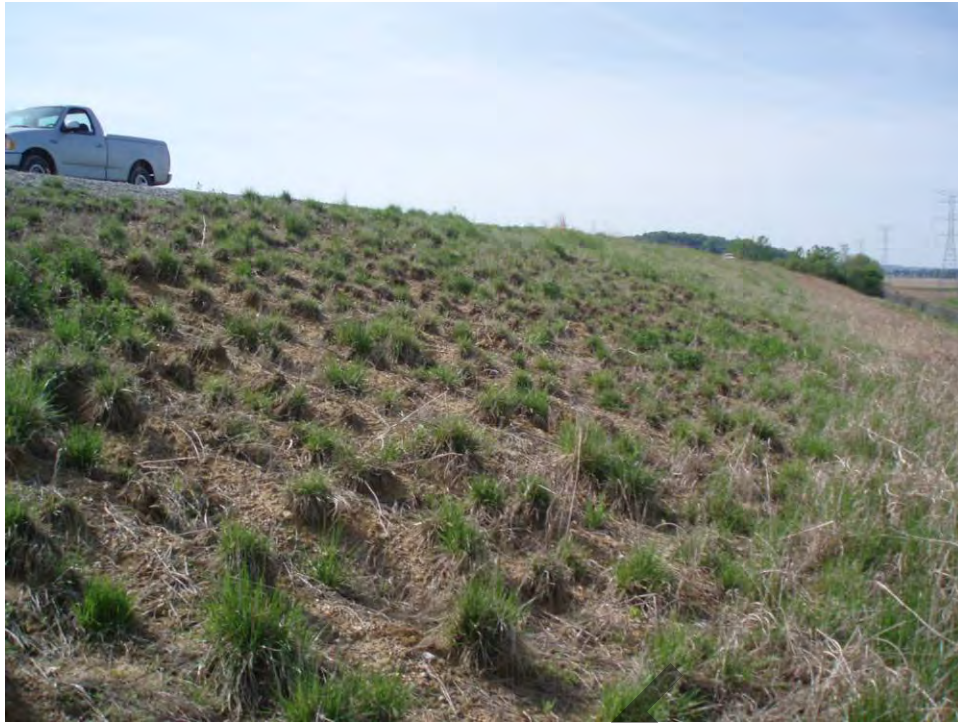
97. Pond D – Typical bare spot and erosion on west embankment exterior slope, looking southeast.

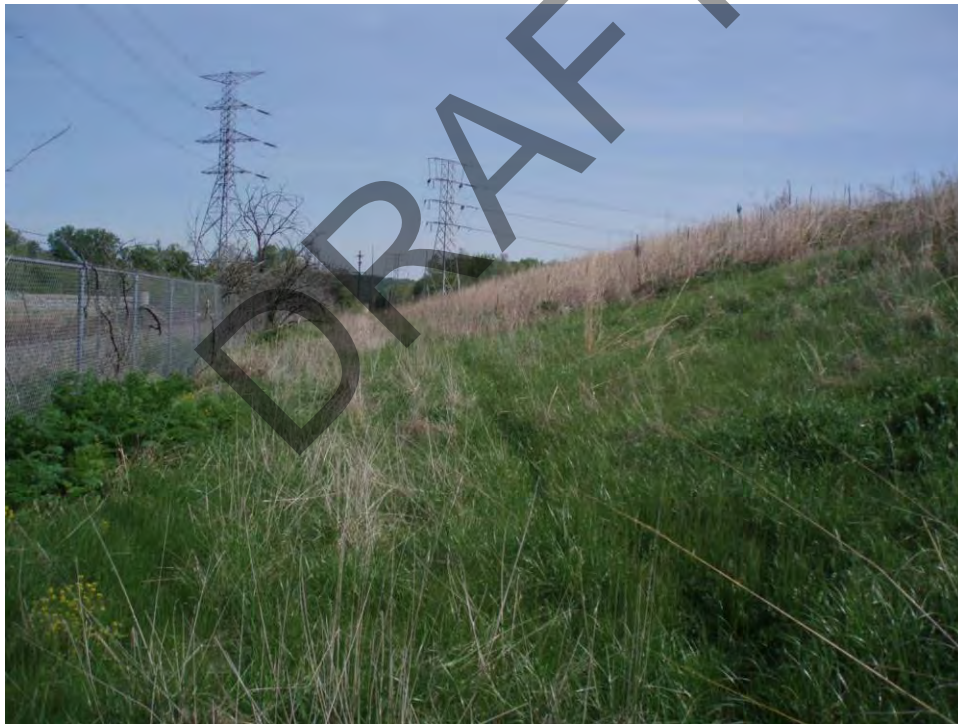
98. Pond D – West embankment exterior slope at toe, looking north.

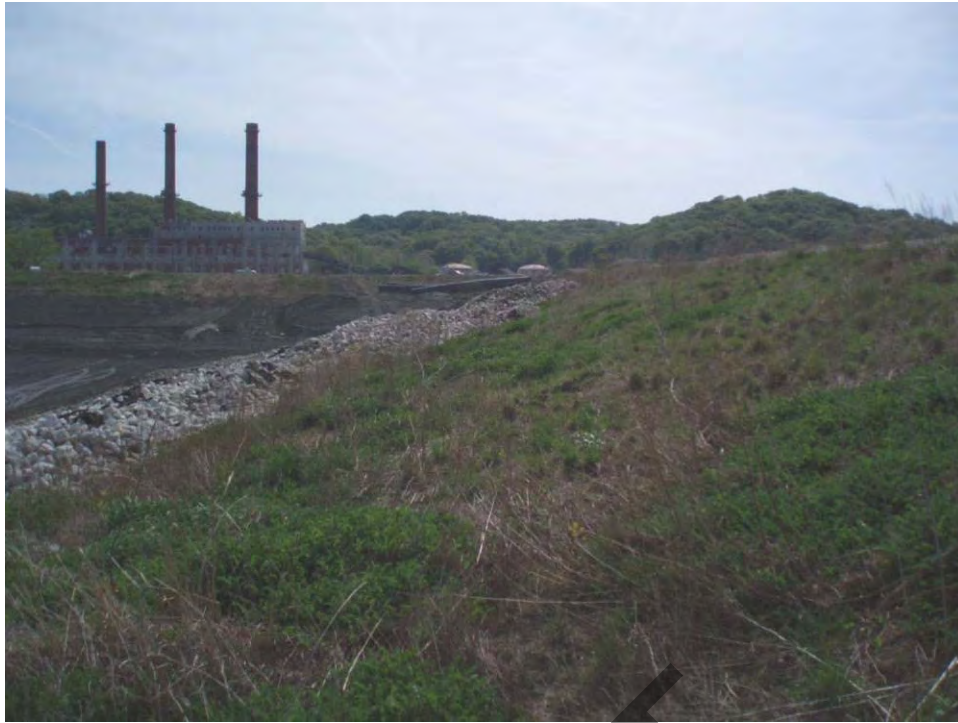
99. North slope of divider embankment D/E, looking east.

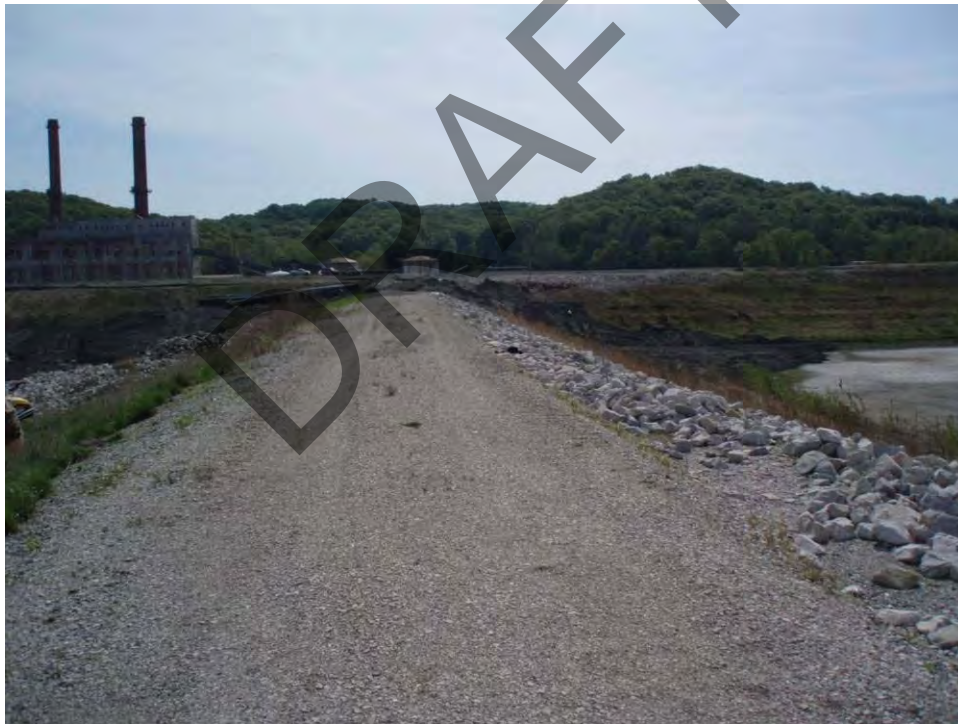
100. Crest of divider embankment D/E, looking east.

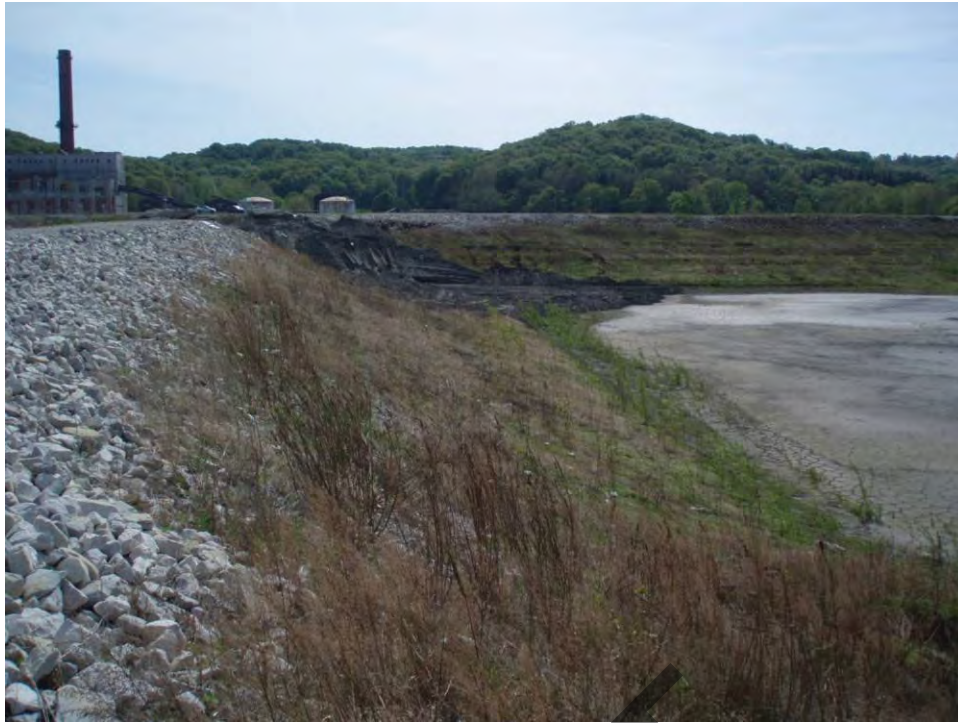
101. South slope of divider embankment D/E, looking east.

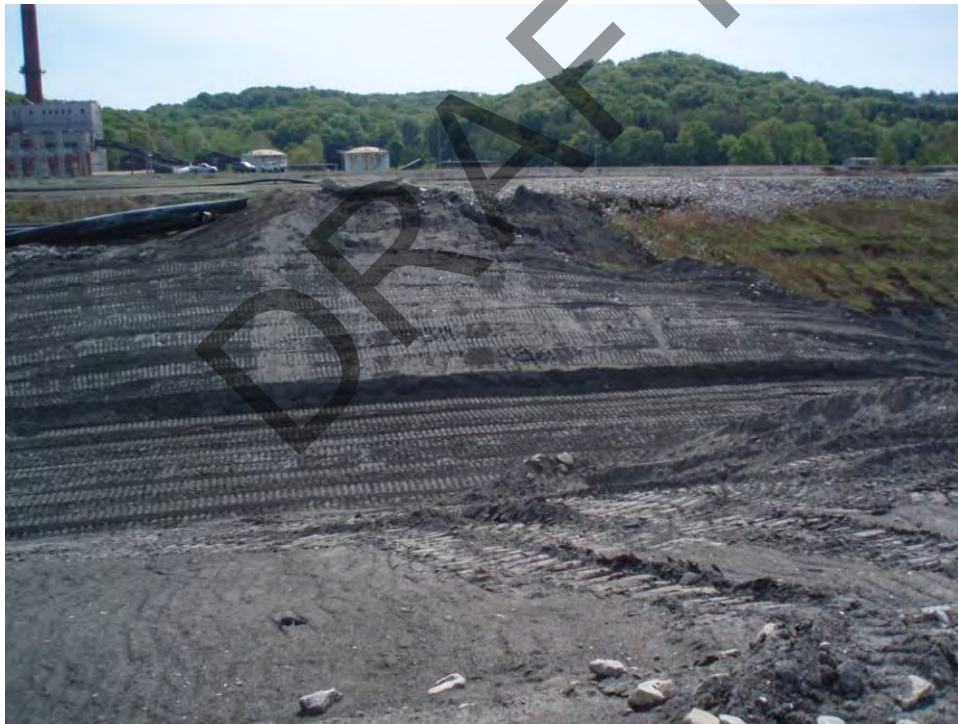
102. Overview of cut in divider embankment D/E for repair work.

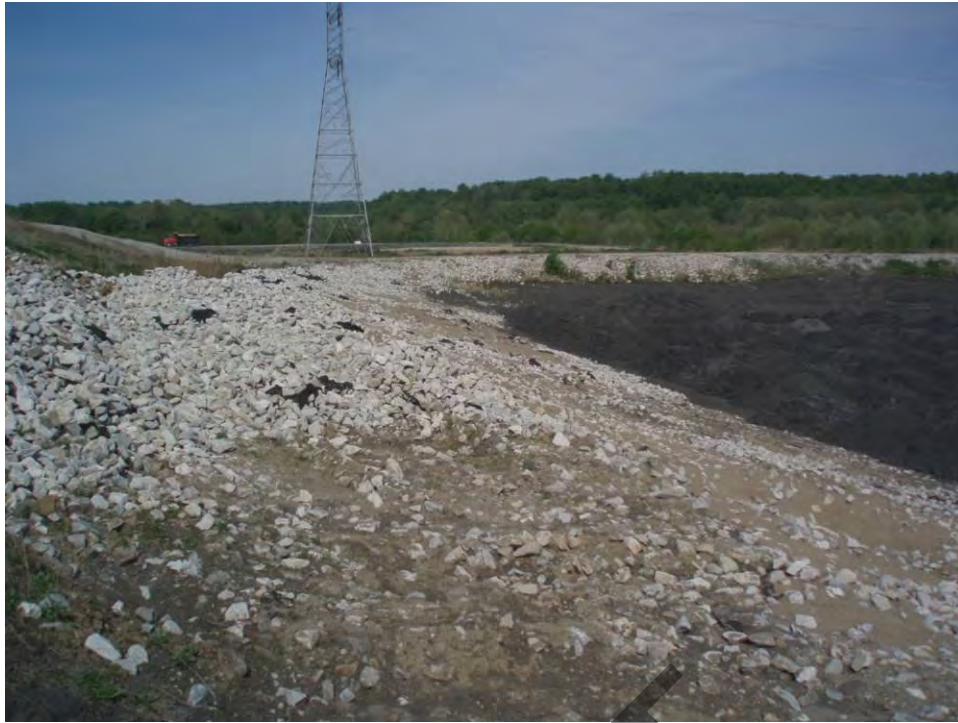
103. North slope of divider embankment D/E, looking west.

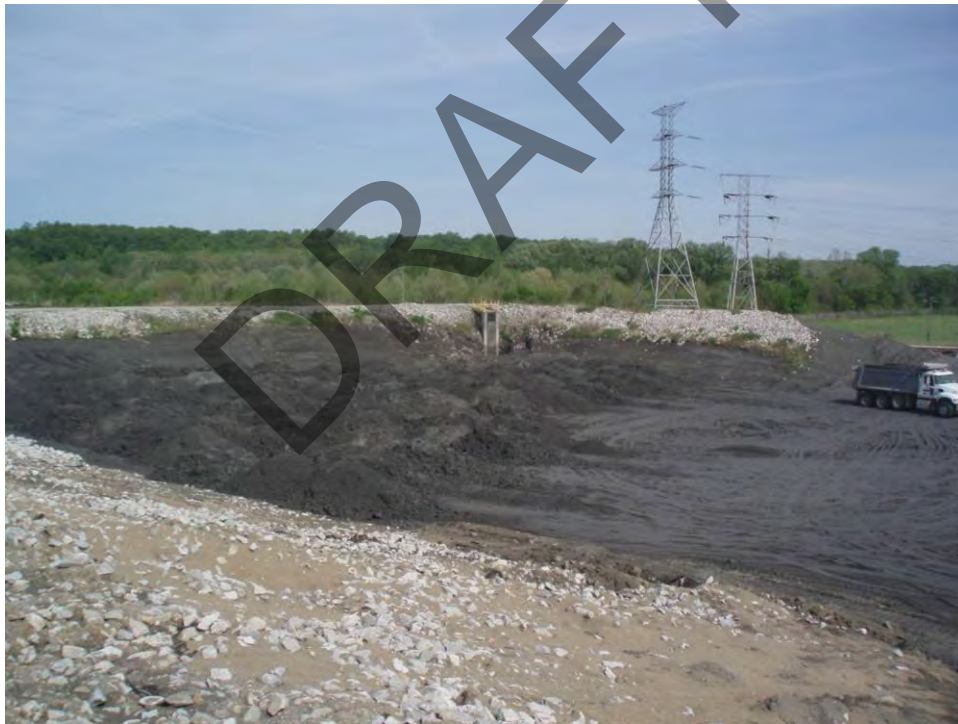
104. Overview of Pond E backfilling operation and Pond E outlet structure, looking northwest.

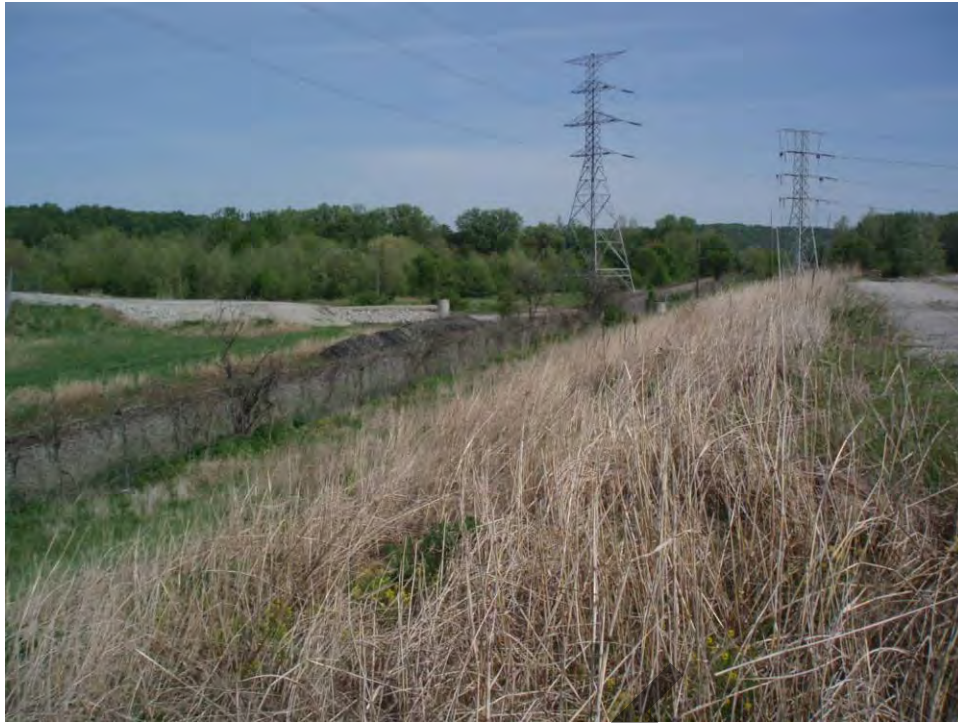
105. Pond E - West embankment exterior slope, looking north.

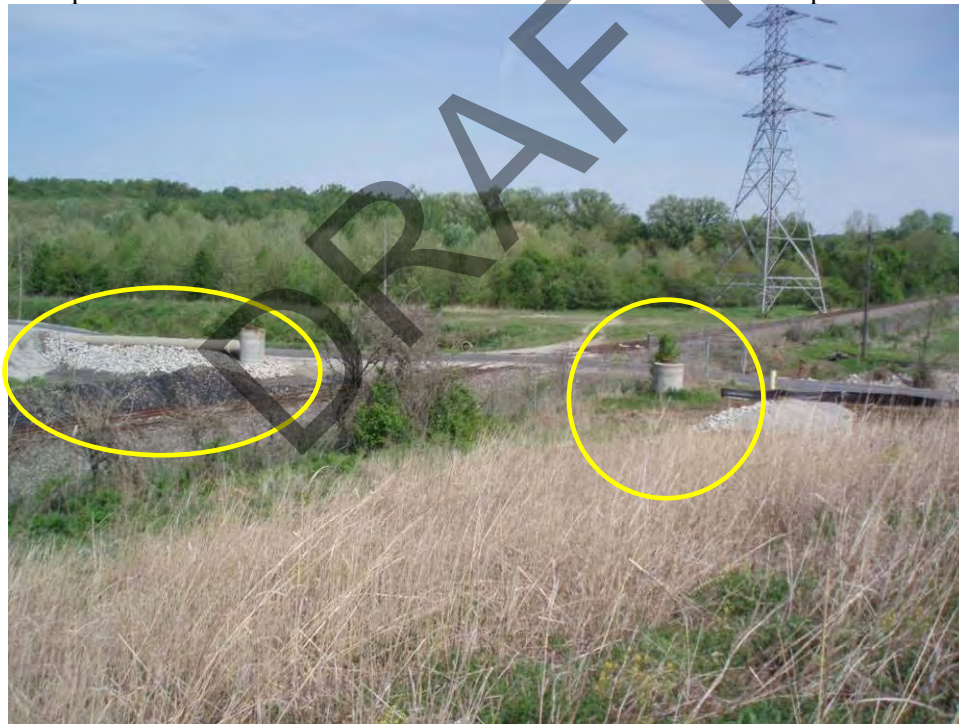
108. Overview of discharge manholes from Pond E into Pond C, looking northwest.

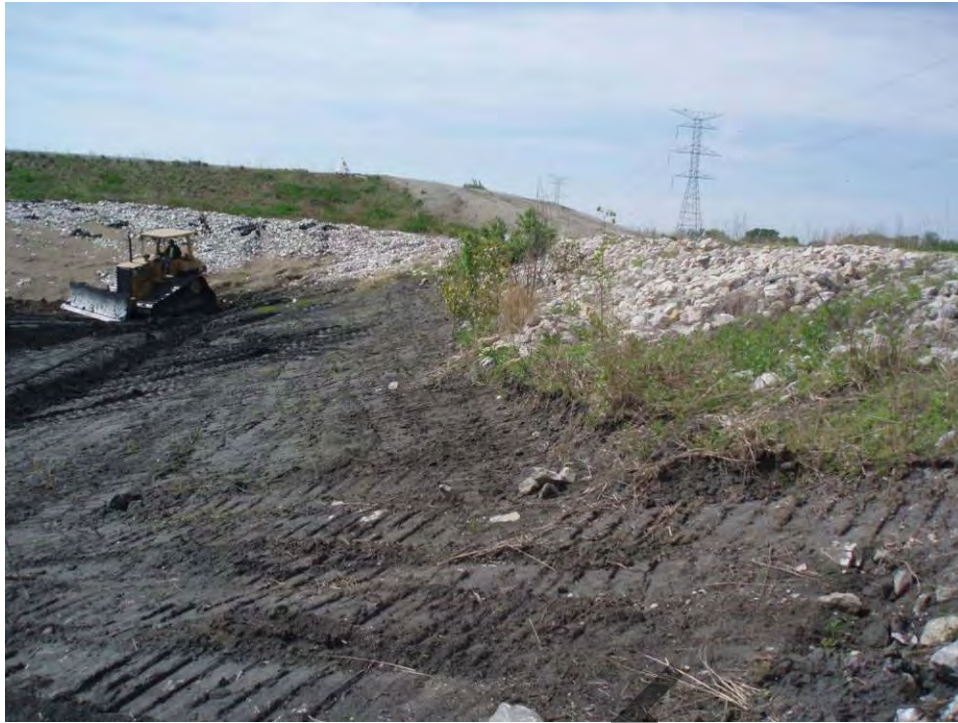
109. Pond E – West embankment interior slope, looking south.

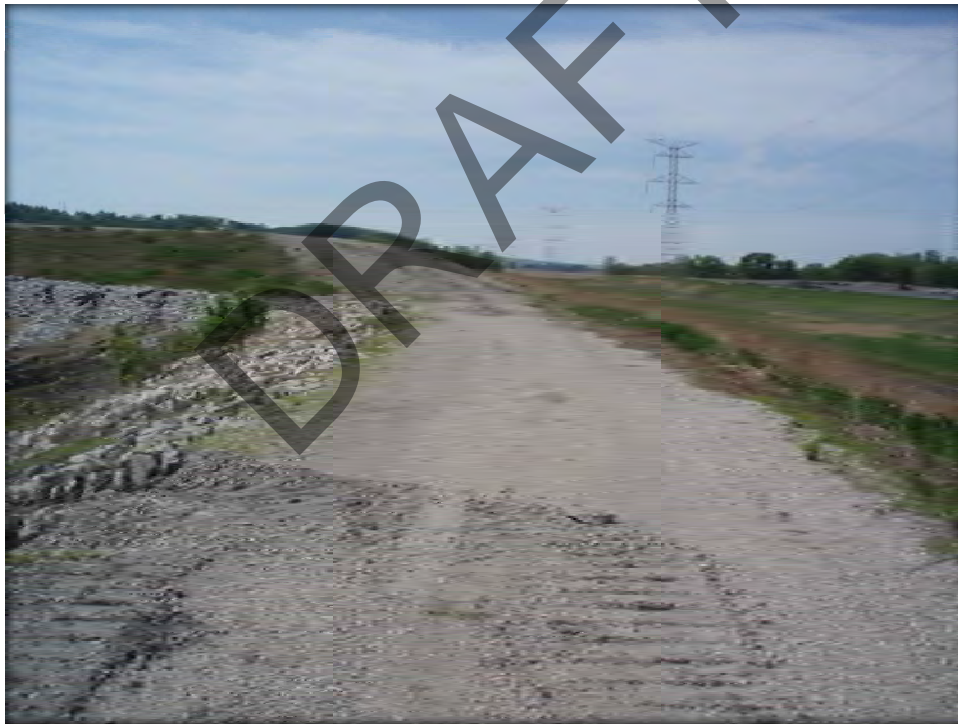
110. Pond E – West embankment crest, looking south.

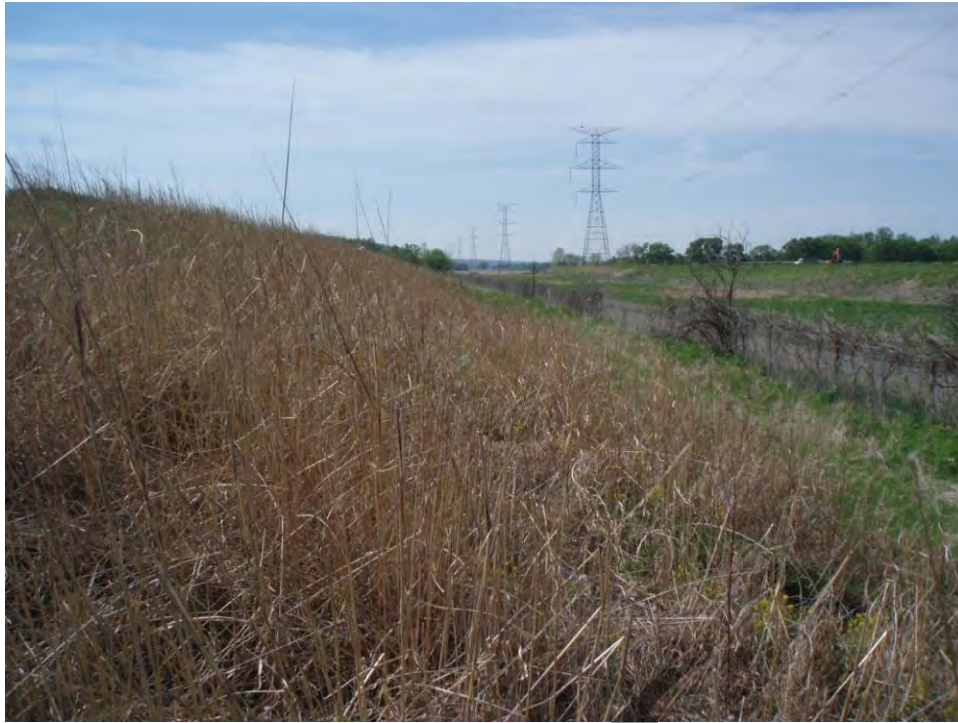
111. Pond E – West embankment exterior slope, looking south.

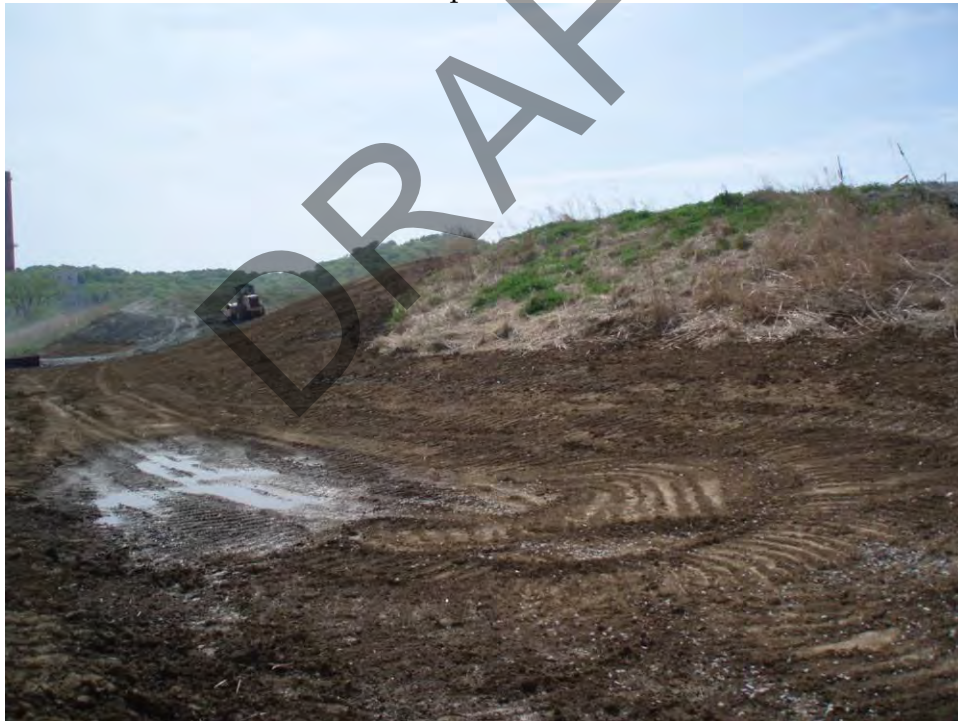
114. Pond E – Downstream area looking south toward failure repair (reconstruction of north embankment).

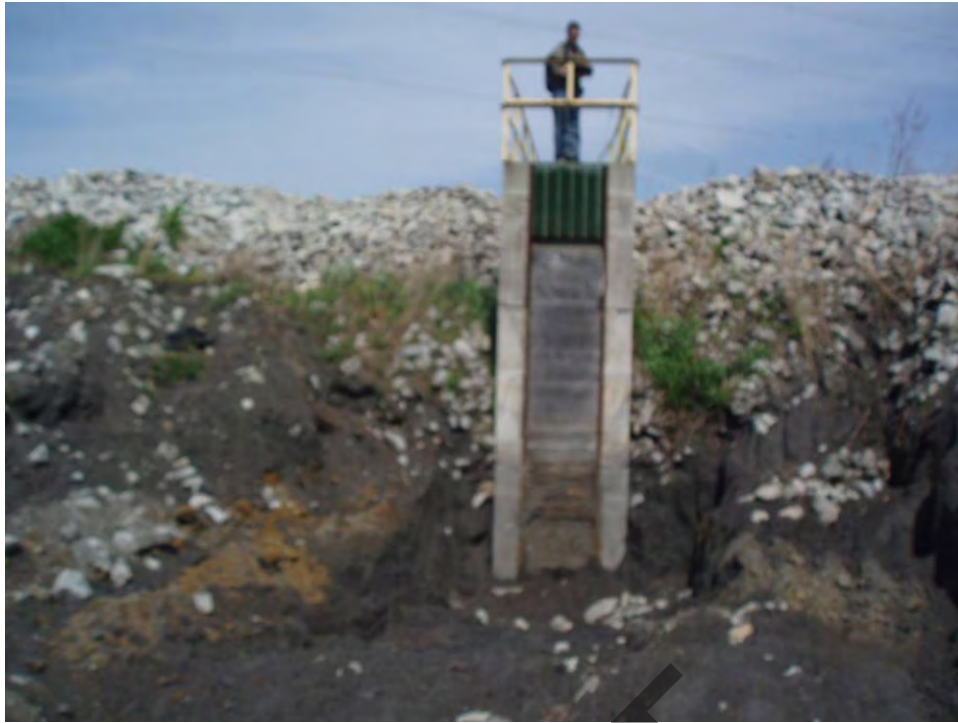
115. Pond E - Overview of outlet control structure with stoplogs and butterfly valve, looking northwest.

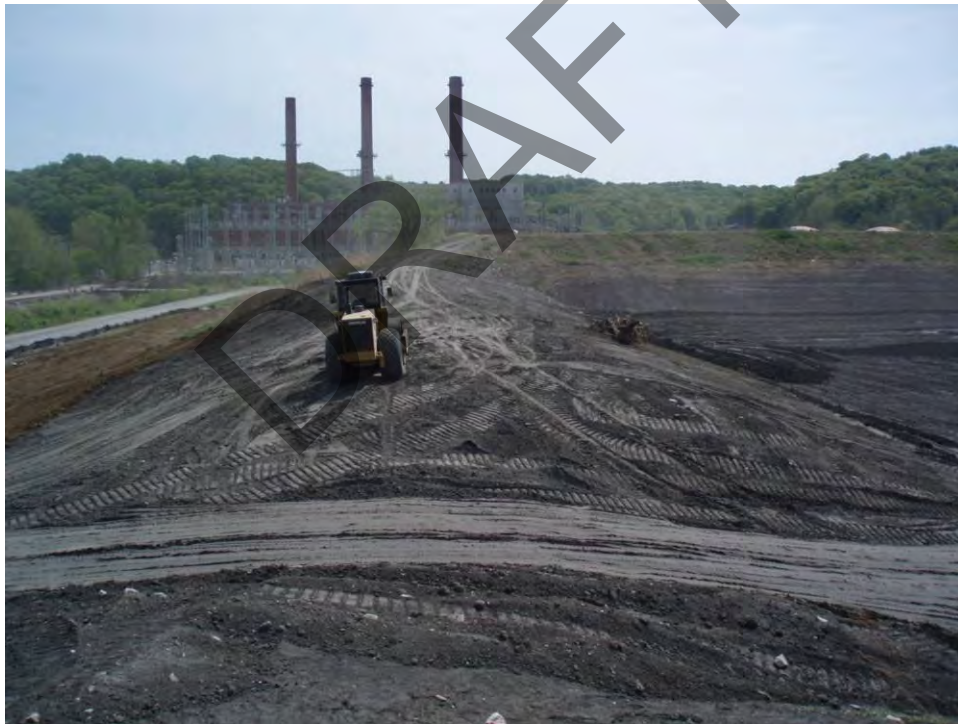
116. Pond E - Overview of north embankment reconstruction, looking east.

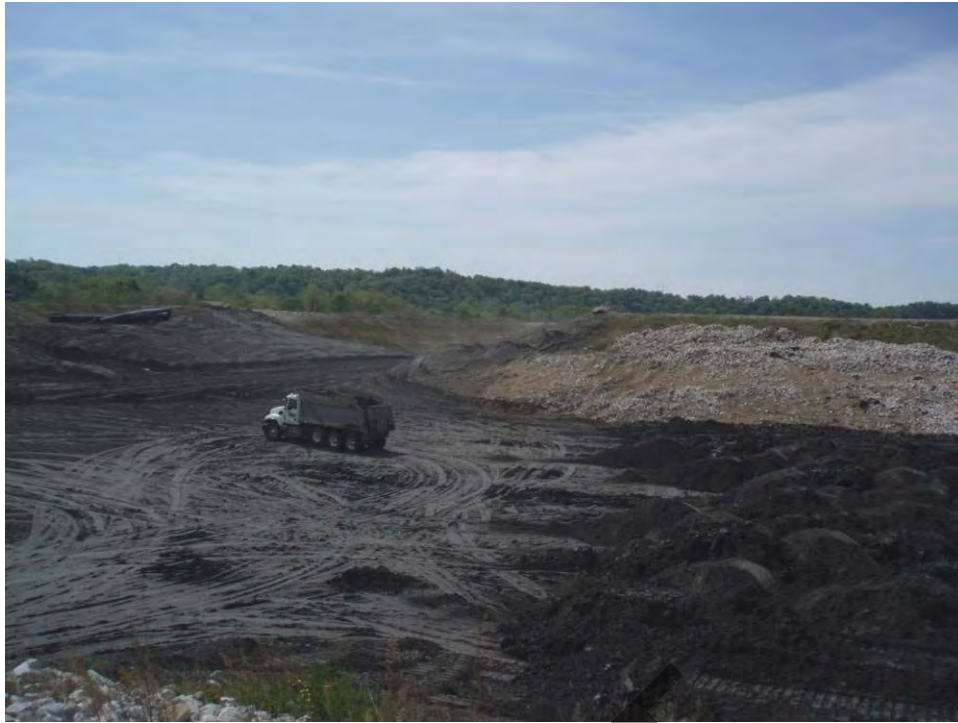
117. Overview of divider embankment D/E reconstruction and Pond E filling operation, looking south.

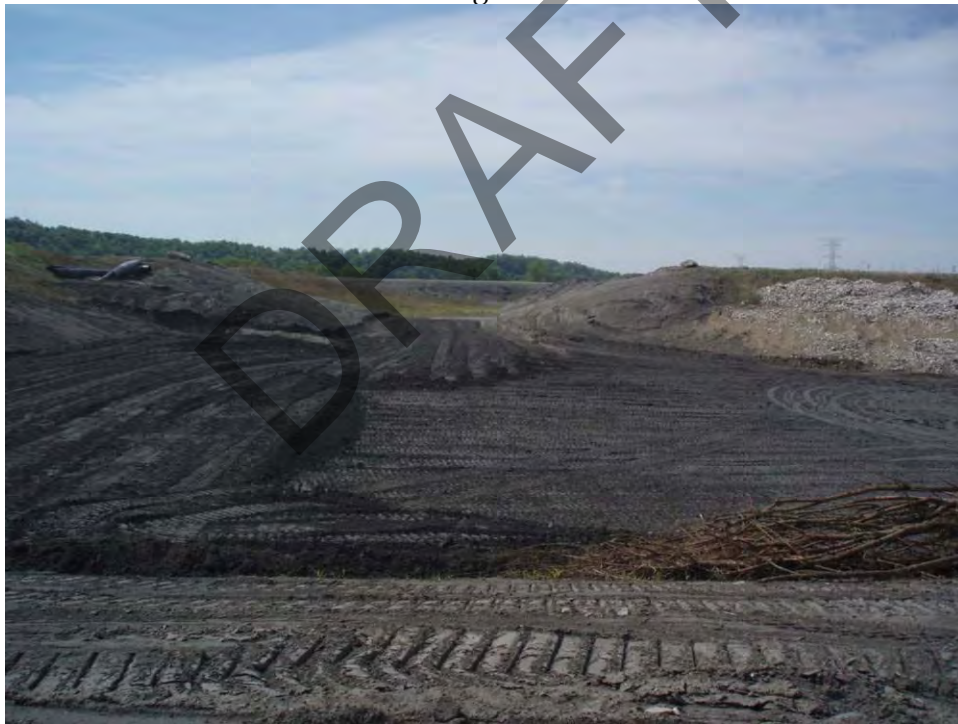
118. Overview of divider embankment D/E reconstruction, looking south.

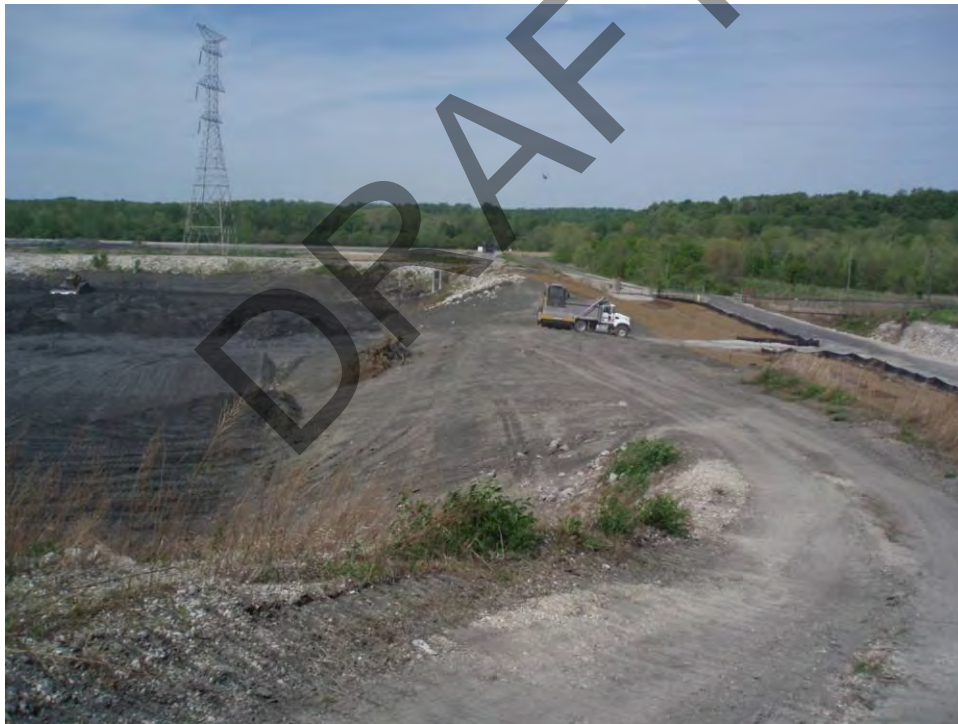
120. Pond E – Overview of north embankment reconstruction, looking west.

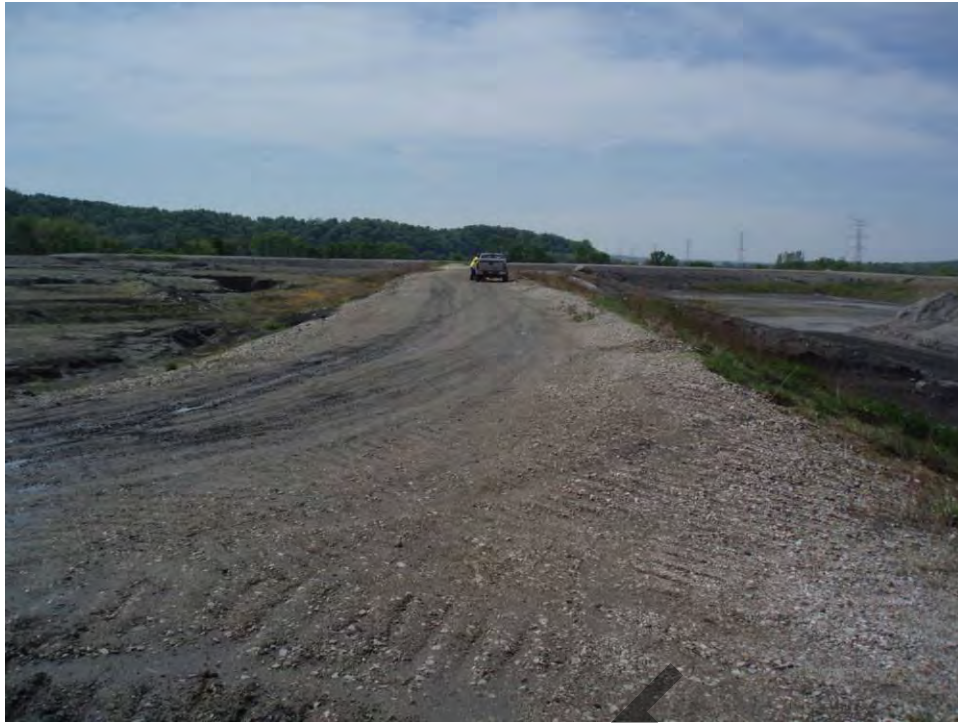
121. Crest of divider embankment D/E, looking south.
